IGNORAL OF WORKING CONDITION AS REASON OF PIPELINE DAMAGE

Abstract: The ignoral of working condition is very frequent reason of equipment damage. The authors in this work states the reasons of pipeline damage; uneven aeration was reason for the starting of corrosion degradation mechanisms, creating of holes and finally pipeline putting out of service.

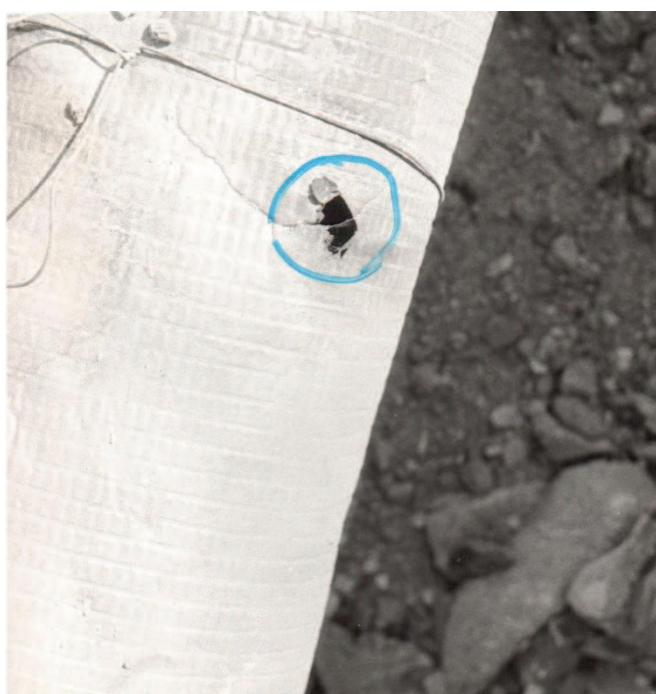
Fig. 11.1. Pipeline damage.

The visual examination by naked eye and at magnitude 25 times indicated that corrosion mechanisms attack the pipeline locally and only on the upper side with final results – holes (see Figure 11.1). Three spec-

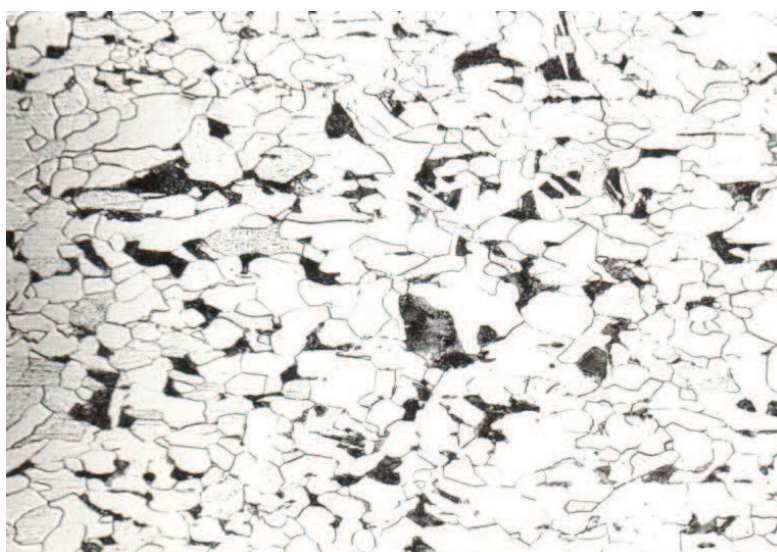
Fig. 11.2. Pipeline microstructure, basic material, mag. 500x, etch. 1 % Nital.

The microstructure of pipeline (see Figure 11.2) is in the non-damage and damage places the same, is created by mixture of ferrite and pearlite with high portion of ferrite (steel with low content of carbon). The microstructure is fine-grained with grain size No. 7. There was not observed interchange of material, was not observed damage caused by mechanical or thermal effects (SKOČOVSKÝ P. 2000, SKOČOVSKÝ P. 2013). The typical local corrosion damages are on the Figure 1.3 and Figure 1.4. The surface of pits and holes are covered by non-uniform, discontinuous oxid layers. The damage has not cavitations origin but the damage is caused by uneven aeration, abnormal aeration (BARTONÍČEK R. 1996, LIPTÁKOVÁ T. 1997). This type of corrosion origin in certain distance from working liquid surface where is the supply of oxygen smaller as direct at surface. There is created the galvanic cell as a result of different aeration – uneven aeration. The pipeline diameter (89 mm) was not suggested correctly; the liquid passage was only 50 ÷ 60 %.

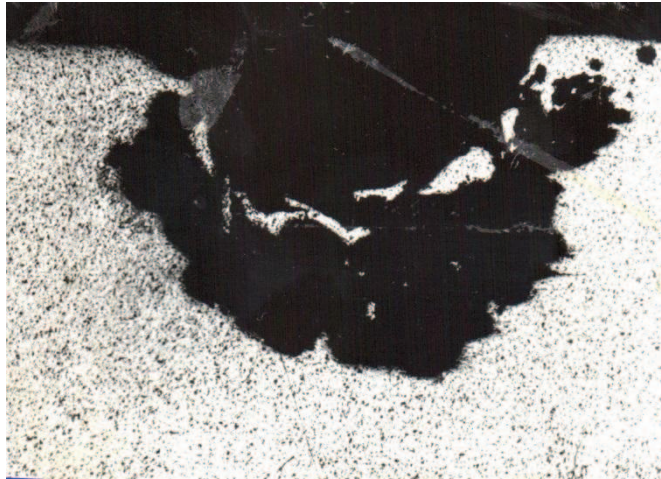
Fig. 11.3. Pipeline, local corrosion damage, mag. 20x, etch. 1 % Nital.

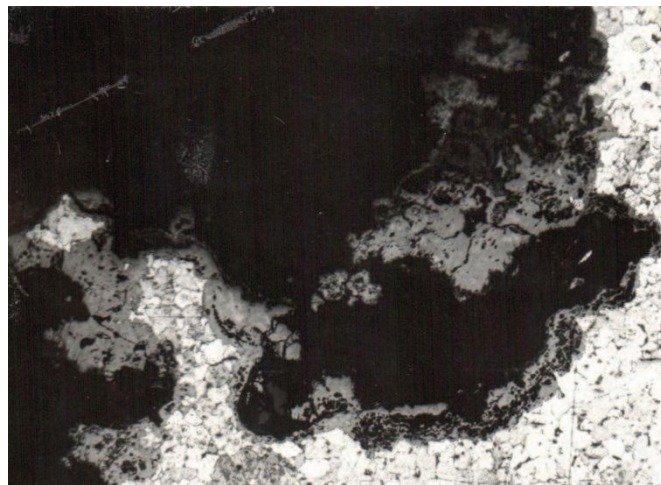
Fig. 11.4. Pipeline, surface of corrosion pits, detail, mag. 100x, etch. 1 % Nital.
